Manhole Inspection Summary

Manhole # S31GG_044MH

Insp Date: 1/17/07 9:01 AM

Location Address: **200 PARK AVE**

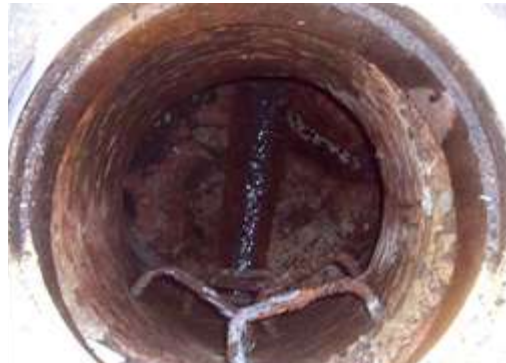
Top View

Corroded steps. Bench debris.

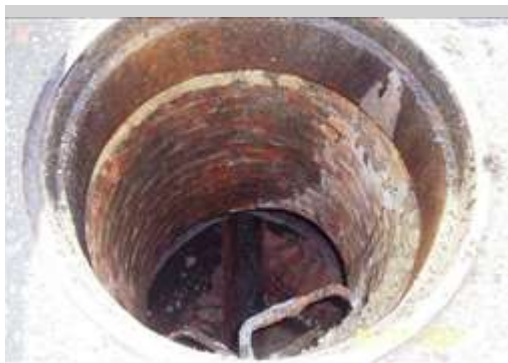
Defect

Frame leaks. Adjustment deterioration and infiltration. Corbel and Barrel infiltration - other side.

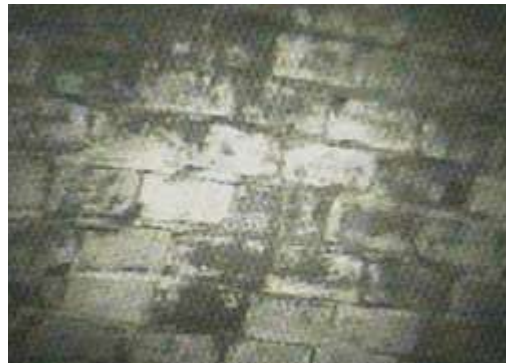
Defect

Barrel infiltration.

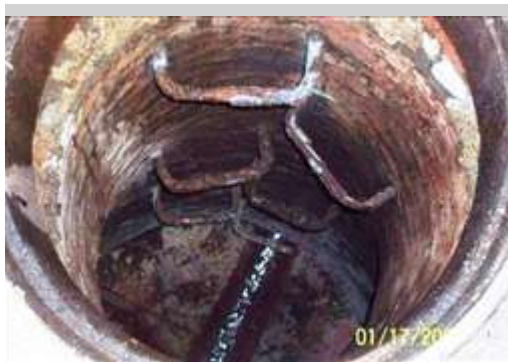
Defect

Frame leaks. Adjustment deterioration and infiltration. Corbel and Barrel infiltration.

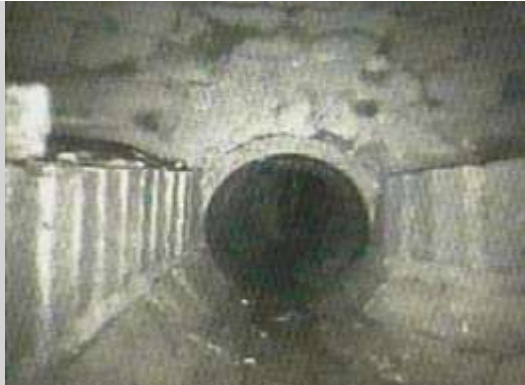
8 in. Circular Gravity Sewer Pipe Out @ 12 O'Clock

Infiltration: **Evidence** Pipe Seal Cond: **Unknown**

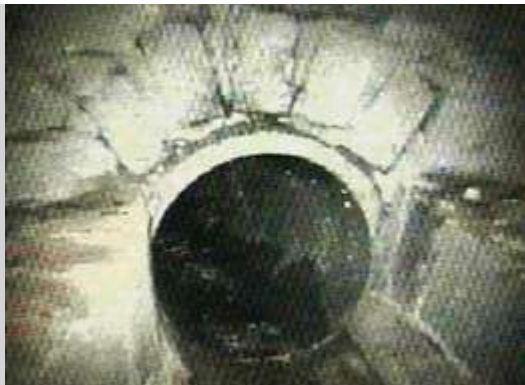
8 in. Circular Gravity Sewer Pipe In @ 3 O'Clock

Infiltration: **Evidence** Pipe Seal Cond: **Cracked**

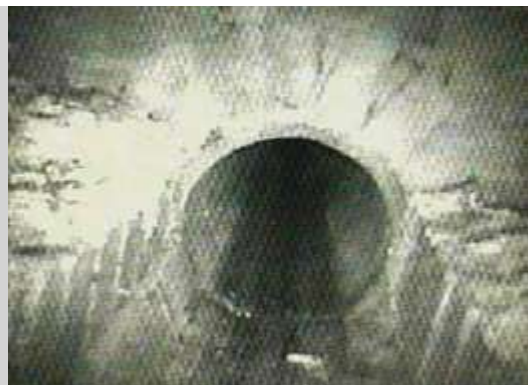
Pipe In @ 6 O'Clock

Infiltration: **Evidence**
